CUSTER NATIONAL FOREST, SIOUX RANGER DISTRICT

RILEY PASS NEWSLETTER

DECEMBER 2011

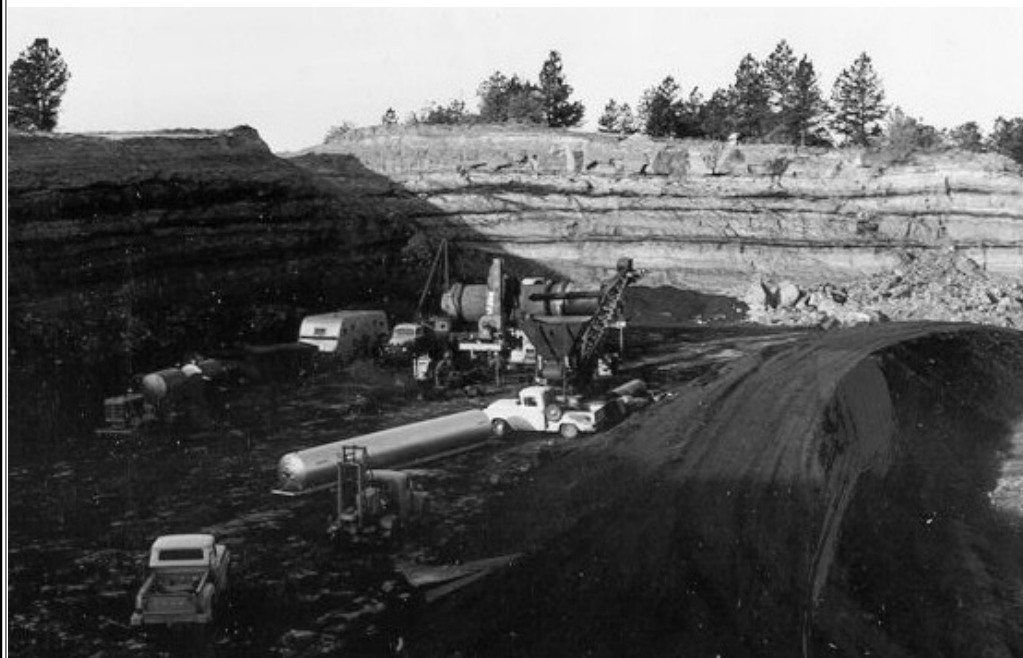
The 250 acre site consists of 12 bluffs first mined in the 1950s (Photo 1). These mined bluffs range in size from a few acres to 150 acres and contain mine wastes with hazardous substances such as: arsenic, molybdenum, thorium, radium, and uranium. Human health and environmental concerns are related to elevated levels of arsenic and radium 226.

Photo 1: Uranium mining, circa late 1950's

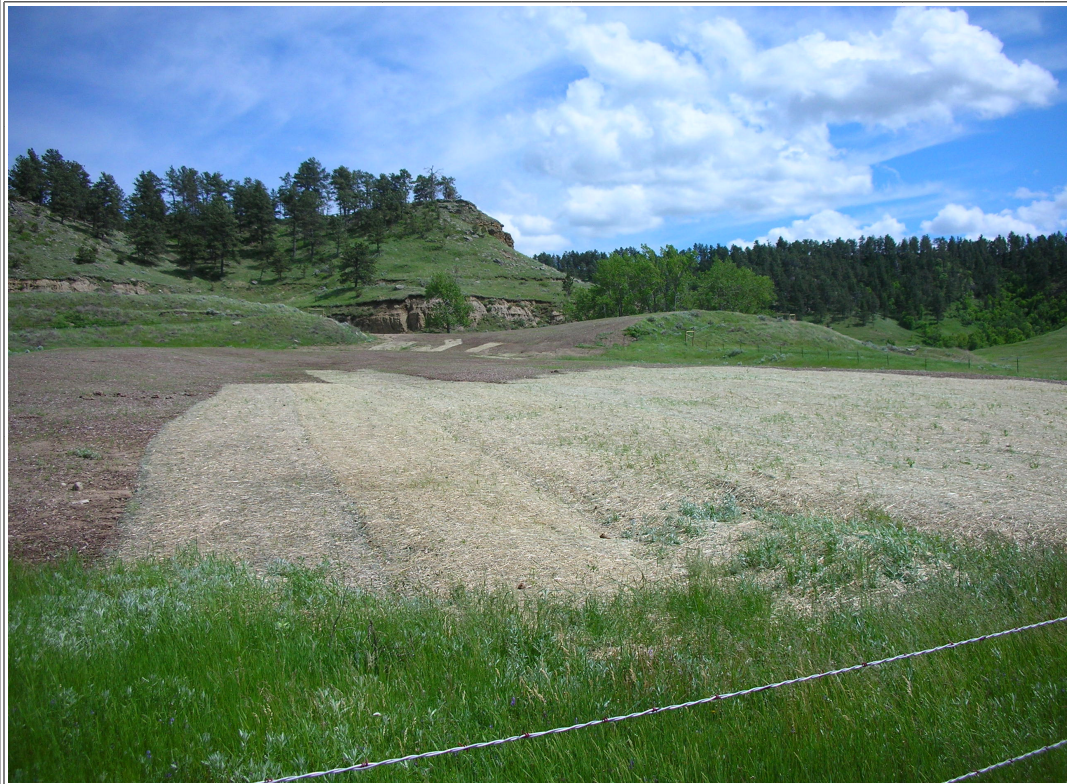
Spring 2011 brought heavy rains causing some minor erosion, but resulting in seeding coming in very well (Photo 3). Erosion control installed on the access road to Bluff K proved effective during the heavy spring rains. Reclaimed areas were fenced and additional erosion control matting was installed in spring 2011. Revegetation continued to progress well over the summer and into fall (Photo 4).

Photo 3 (left)
Late Spring, 6/14/2011
Bluff J-1. Erosion
control and seeding.

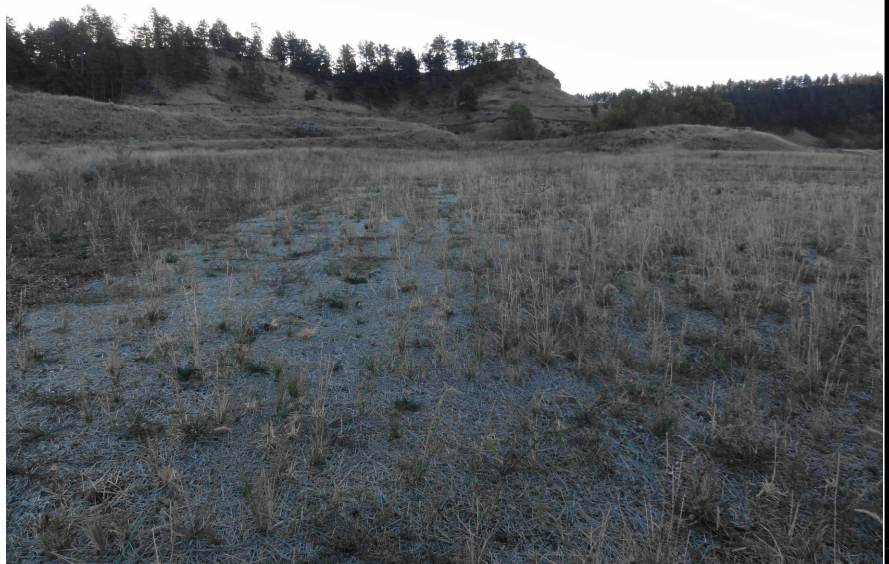
Photo 4 (below) Fall,
10/19/2011 Bluff J-1.
Revegetation at Bluff.

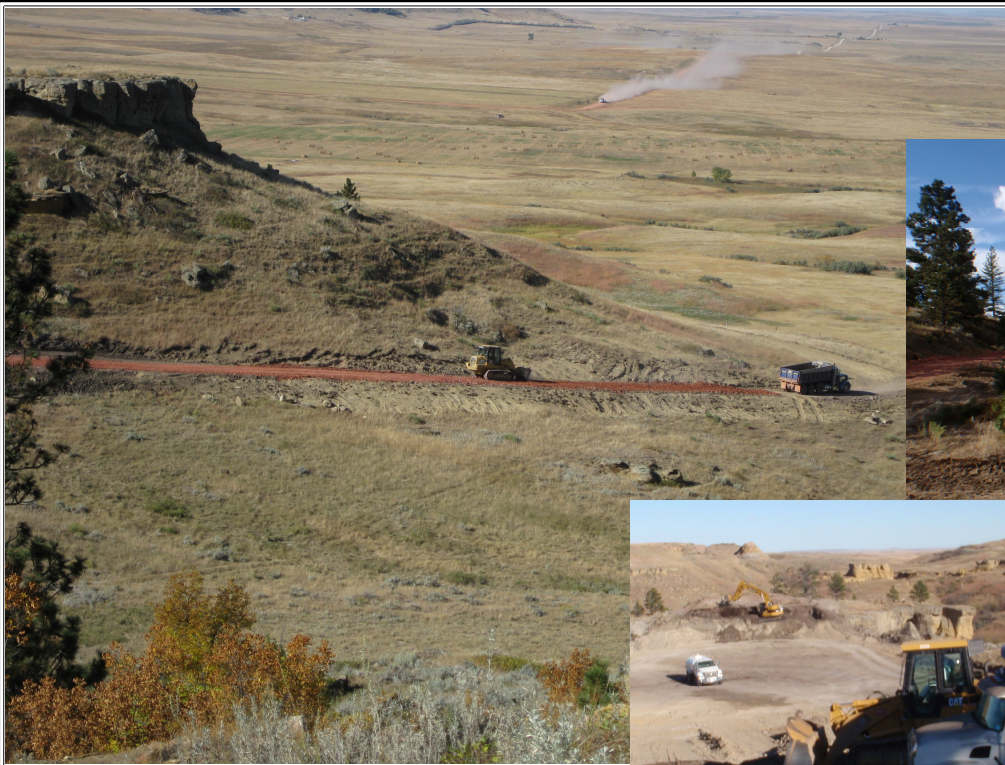
(Photo 5) was constructed for hauling soil from the borrow* area to I-2 and to provide soil for future reclamation of other mined bluffs. Belair suspended work at the end of October and plans to resume operations in May 2012. Temporary erosion control berms were installed around the compacted mine waste and spoils to capture any eroded materials.

Photo 5 (left): 9/28/2011 - Construction of temporary road to soil borrow* area.

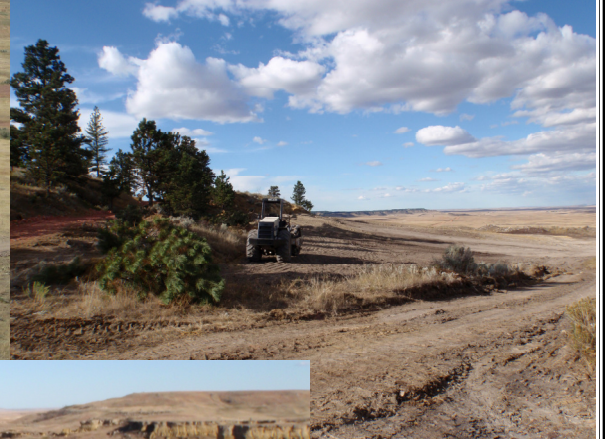
At Bluff I-2 work completed includes consolidating and compacting mine wastes and spoils against the hillside (Photos 6 and 7). A temporary road,

Photo 6 (above) Bluff I-2 compaction of mine waste repository.

In spring 2012, Belair Builders will begin to remove top soil from the borrow area and place it on Bluff I-2. The upper portions of soil in the borrow area will be salvaged and utilized to re-cover the borrow area after soil is extracted. All disturbed areas will be seeded with a native weed-free seed mix. Steeper slopes will be covered with biodegradable erosion matting. A permanent earthen berm will be constructed at the base of the compacted and capped mine waste to further prevent erosion and sediment transport.

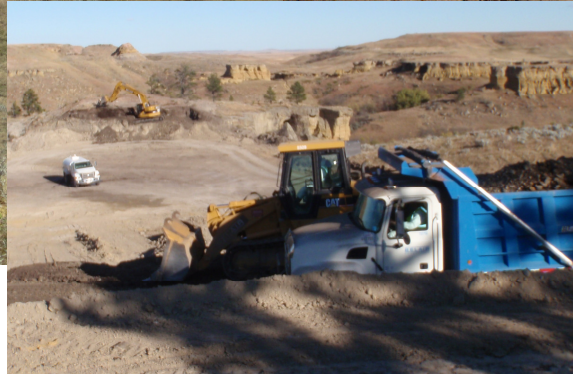
Photo 7 (left) Bluff I-2 waste removal viewed from repository.
